Flightdeck Automation Issues: An Aviation Safety Reporting System Analysis

DOT/FAA/CT-TN95/11

This document describes the second of three studies relating to the analysis of the Aviation Safety Reporting System (ASRS) with regards to human factors aspects concerning the implementation of data link into the flightdeck. The ASRS database contains thousands of reports concerning actual or potential deficiencies which may compromise the safety of aviation operations in the National Airspace System (NAS). The purpose of this study was twofold: first, to provide the Federal Aviation Administration (FAA) an account of the problems associated with today's highly automated aircraft; and secondly, to report the likelihood that these problems may be exacerbated and/or lessened due to the implementation of data link into the flightdeck.

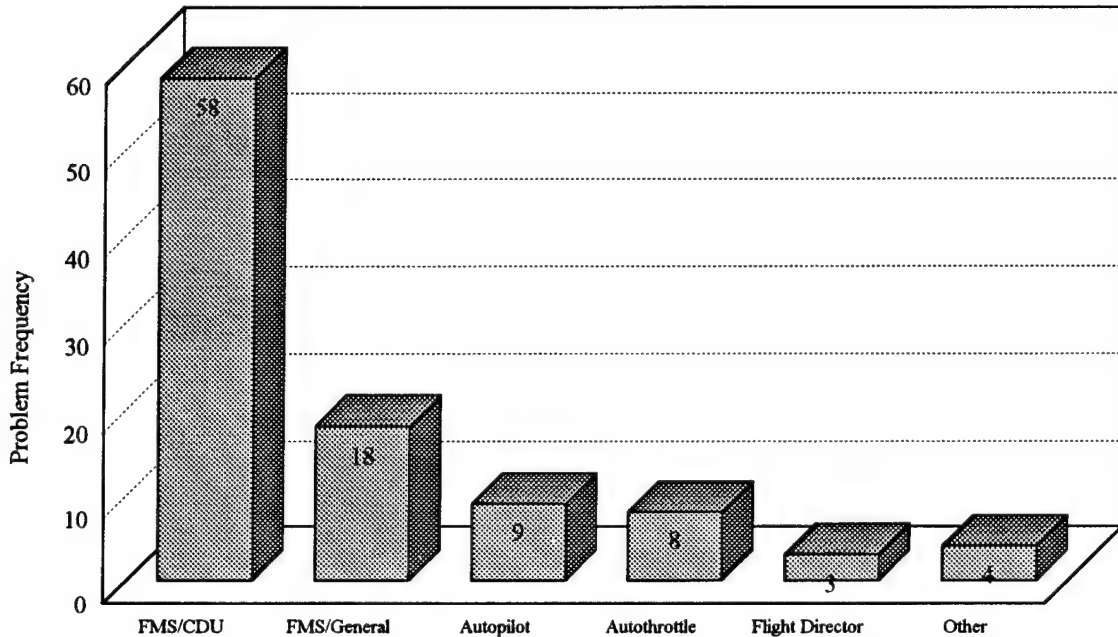
FIGURE 1. AUTOMATION EQUIPMENT

The FMS is comprised of many interconnecting systems. Figure 1 denotes the breakdown of the ASRS reports into individual FMS components. The FMS Control Display Unit (CDU) was directly involved in over half (58 percent) of the incidents reported. A separate class (FMS/General) was created to indicate those reports where the specific FMS component was inconclusive; 18 percent of the incident reports fell in this category. The remaining reports were directly attributed to either the autopilot (9 percent), autothrottle (8 percent) and flight director (3 percent) systems.

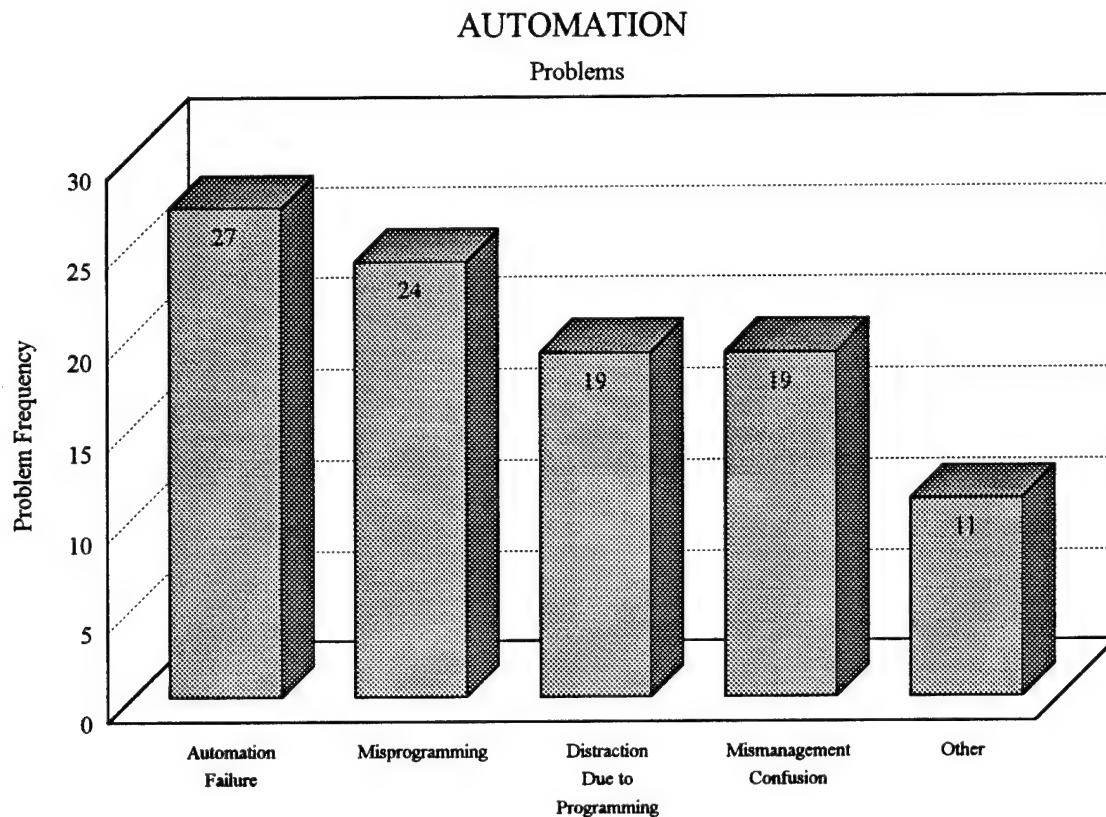
FIGURE 2. AUTOMATION PROBLEMS

Figure 2 illustrates the results of the detailed analysis. Although the problems are separated in unique categories, crews reported monitoring deficiencies, complacency, etc., throughout each problem area. In order of their percentage, the following major problems are noted as follows: (1) Automation Failure (27 percent), (2) Misprogramming (24 percent), (3) Distraction due to Programming (19 percent), and (4) Mismanagement and Confusion (19 percent).

In retrospect, observing the various classifications of automation problems (figure 2) one can see the association with related literature. For instance, Sheridan's (Sheridan, 1991) concept of human-centered automation portrays the pilot undergoing four supervisory activities amidst automation. Sheridan addresses each activity in a conceptual framework, where each function is related to and is dependent upon another. The four supervisory activities of human-centered automation are: Planning, Deciding, Monitoring, and Intervening.

Each supervisory activity is represented across the automation problems shown in figure 2. The first two activities, Planning and Deciding, deal with the abilities of the crews to understand the performance characteristics of the navigation systems and how to program them to achieve specified mission goals. Not surprisingly, these behaviors are manifested within the majority of automation incident problems; i.e., approximately 62 percent of the problems reported were directly attributed to the programming (24 percent, Misprogramming; 19 percent, Distraction due to Programming) and overall mismanagement (19 percent, Mismanagement/Confusion) of the navigation systems.

The third supervisory activity, Monitoring, is the ability of the crew to attend to the automation systems, and to derive information about the current state of the aircraft. Although not uniquely addressed in figure 2, each automation problem contained incidents where the crews exhibited monitoring deficiencies.

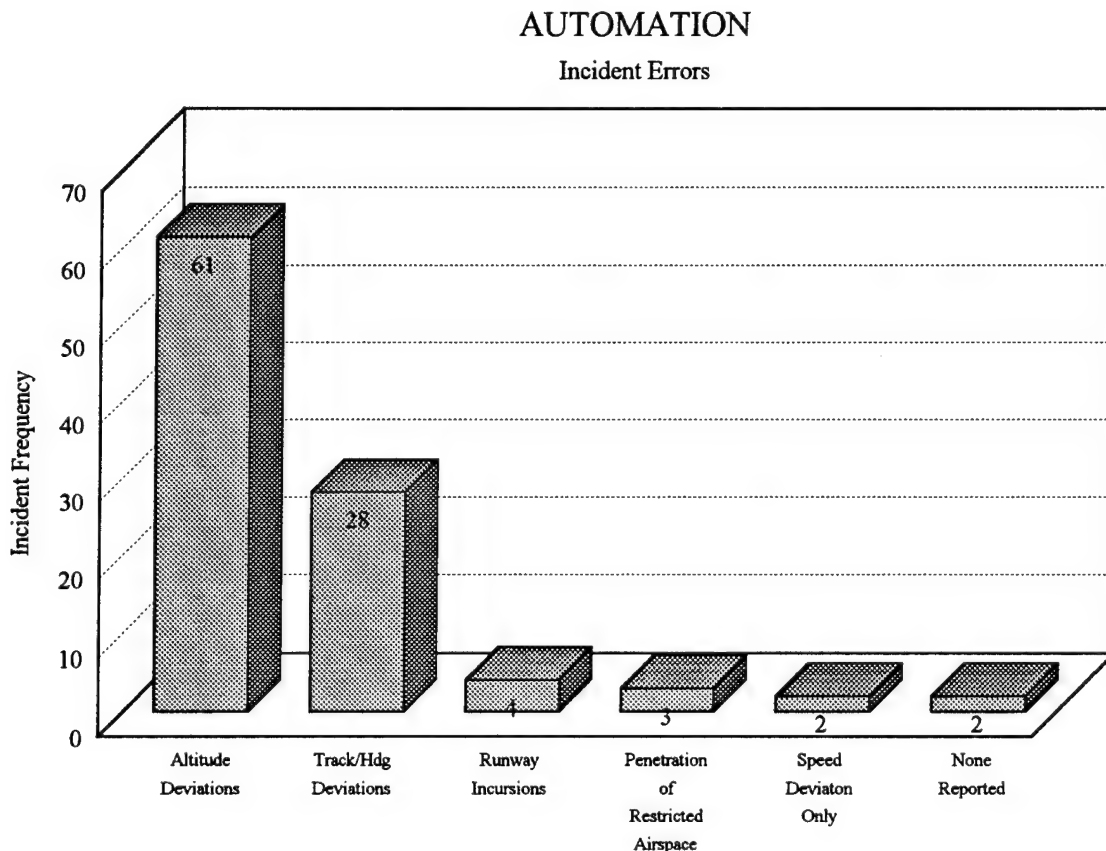
FIGURE 3. INCIDENT ERRORS

This section will describe incident errors which are the byproducts of the automation problems discussed in section 5.2.2. Examples of incident errors are altitude, heading, and speed deviations. The classification of incident errors are provided in figure 3.

The majority (89 percent) of incident errors were a result of an altitude or track deviation. Recognizing that automation systems are designed to maintain controlled flight, the propensity for these types of errors is not difficult to infer. The real question is: What circumstances, under controlled flight, are causing these deviations?

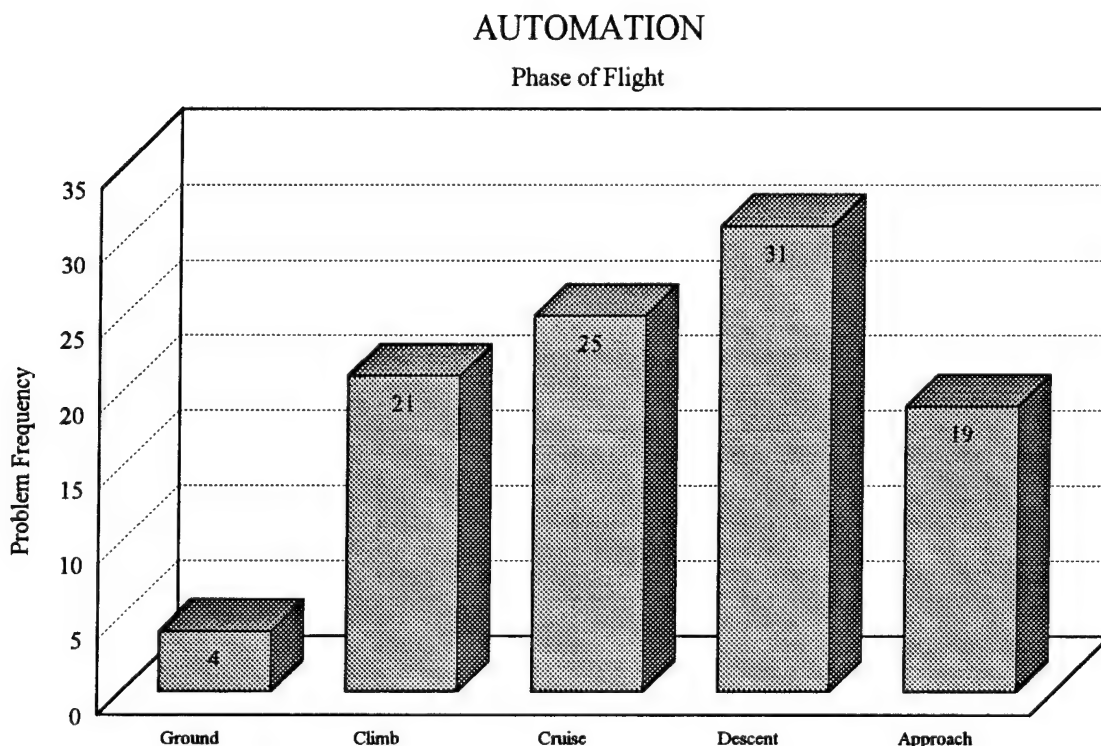
FIGURE 4. PHASE OF FLIGHT

With regards to figure 4, the cruise portion of flight resulted in only 25 percent of the reported incidents. It appears that more incidents (71 percent) were occurring in expected high workload conditions (climb, descent, and approach) than during expected low workload conditions (cruise).

The ability of pilots to remain vigilant throughout the flight depends on a variety of factors. For example, periods of low workload, such as those endured over long oceanic flights may contribute to a lack of vigilance. Conversely, vigilance may also decrease in periods of extreme workload conditions. To help visualize this, two figures were created and are provided below. The first provides overall error percentages by phase of flight (figure 4), and the second (figure 5), reveals the types of automation problems occurring during each phase.

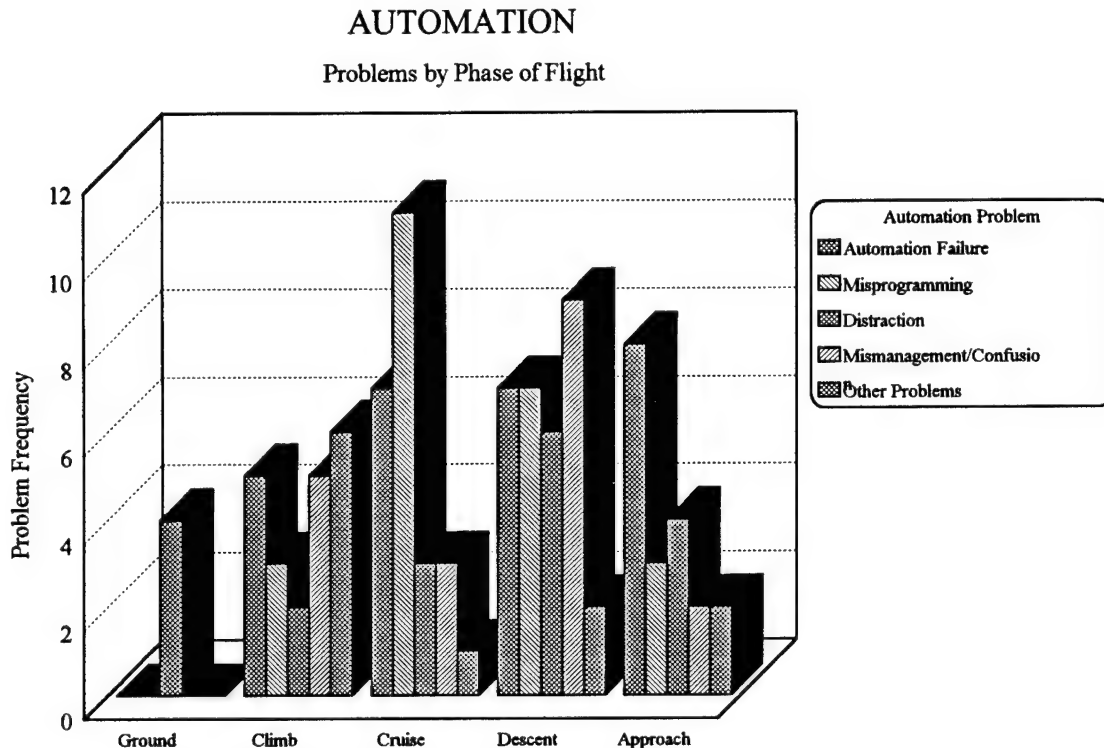
FIGURE 5. PROBLEMS BY PHASE OF FLIGHT

Moreover, almost half of the reported incidents during cruise flight were due to misprogramming of the FMS on the ground (see figure 5, the high peak). The crews were not aware (lack of monitoring?) of the programming error until later in cruise flight. What makes it even more interesting is that the crews were sometimes informed by air traffic control (ATC); almost always resulting in a gross navigational error.

During the descent and approach phase, the crews are working the radios, receiving last minute updates on arrival runways, Automated Terminal Information Service (ATIS), etc., in addition to monitoring the flight management system. It could be quite easy for the crews to ignore the automation in order to attend to other flight duties. However, as reported by the pilots themselves, excessive workload demands were only found in 6 percent of the reports (see section 5.3.6, Further Automation Issues). The factors most responsible for errors occurring in the post-cruise regime were: automation failure (28 percent); mismanagement, confusion (22 percent); misprogramming (20 percent) and distraction due to programming (18 percent).
